NOVEC Wildwood Substation Permit Application

VA Department of Environmental Quality VWP 2 U.S. Army Corps of Engineers 17-SPGP-01

January 26, 2021

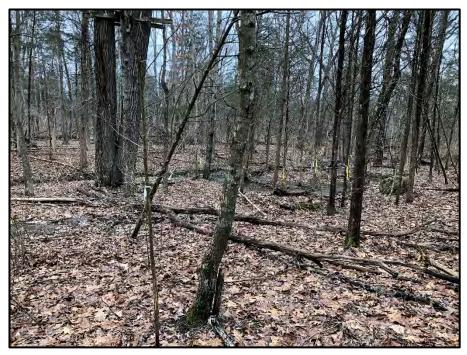
Figure 12. Stream and Associated Flagged Wetland in the Northern Portion of the Project Area; View to the East.

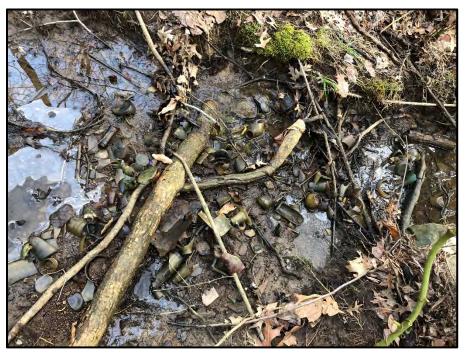
Figure 14. Landscape Feature 1 – Twentieth Century Bottle Dump; View to the North.

Landscape Feature 1 represented a twentieth century bottle dump in a stream bed. No intact bottles were observed, and the majority of the broken bottles appeared to represent large alcohol jugs, though beer bottles were also present (Figure 14).

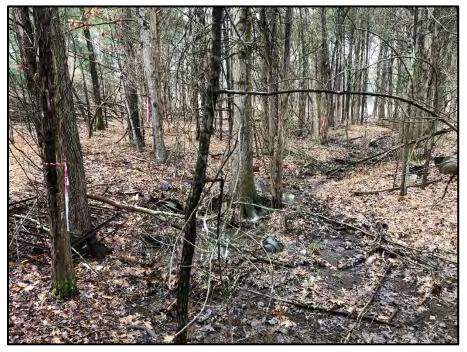
Figure 15. Landscape Feature 2 – Twentieth Century Trash Dump; View to the East.

Landscape Feature 2 represented a twentieth century trash dump in wooded wetlands. This dump was located a short distance northeast of Landscape Feature 1 and included a metal bed frame and other debris (Figure 15).

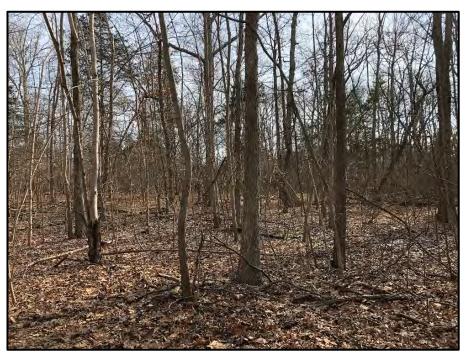
Figure 16. General Vicinity of Site 44LD0468 in Wooded Wetlands; View to the East.

A representative shovel test for Site 44LD0468 consisted of two strata in profile (STP S21). Stratum I was characterized as a layer of 10YR3/4 dark yellowish-brown loam, which extended in depth from approximately 0 to 0.5 feet below ground surface (Topsoil). Underlying Stratum I was Stratum II, a layer of 10YR5/4 yellowish-brown clay. Stratum II was excavated from approximately 0.5 to 0.9 feet below ground surface (Subsoil) (Table 7).

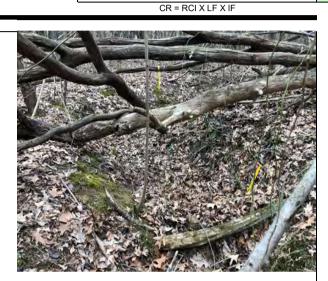
Impact is associated with the construction of a 8.6 ft tall retaining wall on the northeast corner of the pad site. The wall was designed to avoid impacts to the perennial stream.

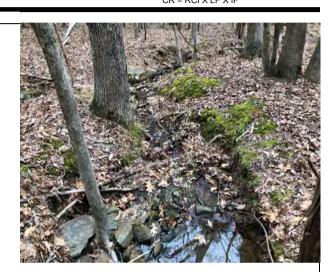
Impact associated with the installation of a 24-inch RCP approximately 115 ft in length with a riprap outfall.
